Analysis of Eddy-Current Testing and Metallographic Examinations for Corrosion Damages of Heat Exchanging Tubes in NPP Steam Generators

Tetiana Kovalenko, Stepan Lys*, Volodymyr Vostres

Lviv Polytechnic National University, 12, S. Bandery Str., Lviv, 79013, Ukraine

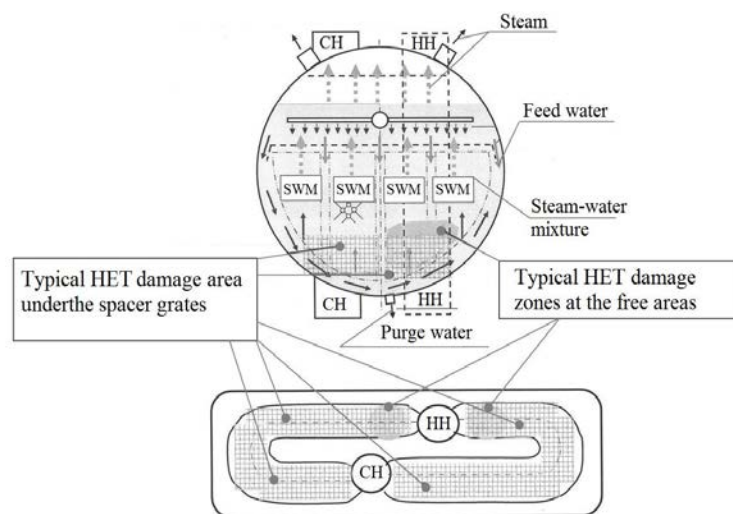
The results based on the analysis of HET corrosive defects of the NPP SG with WWER at Ukrainian and foreign NPP are cited in papers [1], [3]–[7]. It was determined that the corrosion defects on free areas and under spacing elements tend to appear mainly at a bottom of SG tube bundles (Fig. 1).

Whereupon the defects on free areas localize mainly near hot header (HH). The defects under spacing grates are also situated at the SG bottom but distributed more evenly along with the tube bundle.

Fig. 1. The steam generator in cross section and plan.

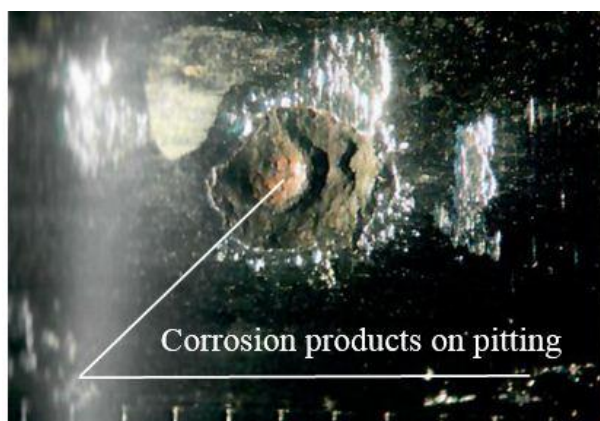
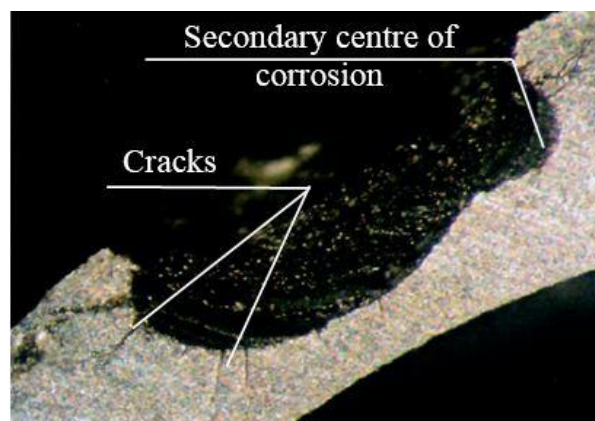
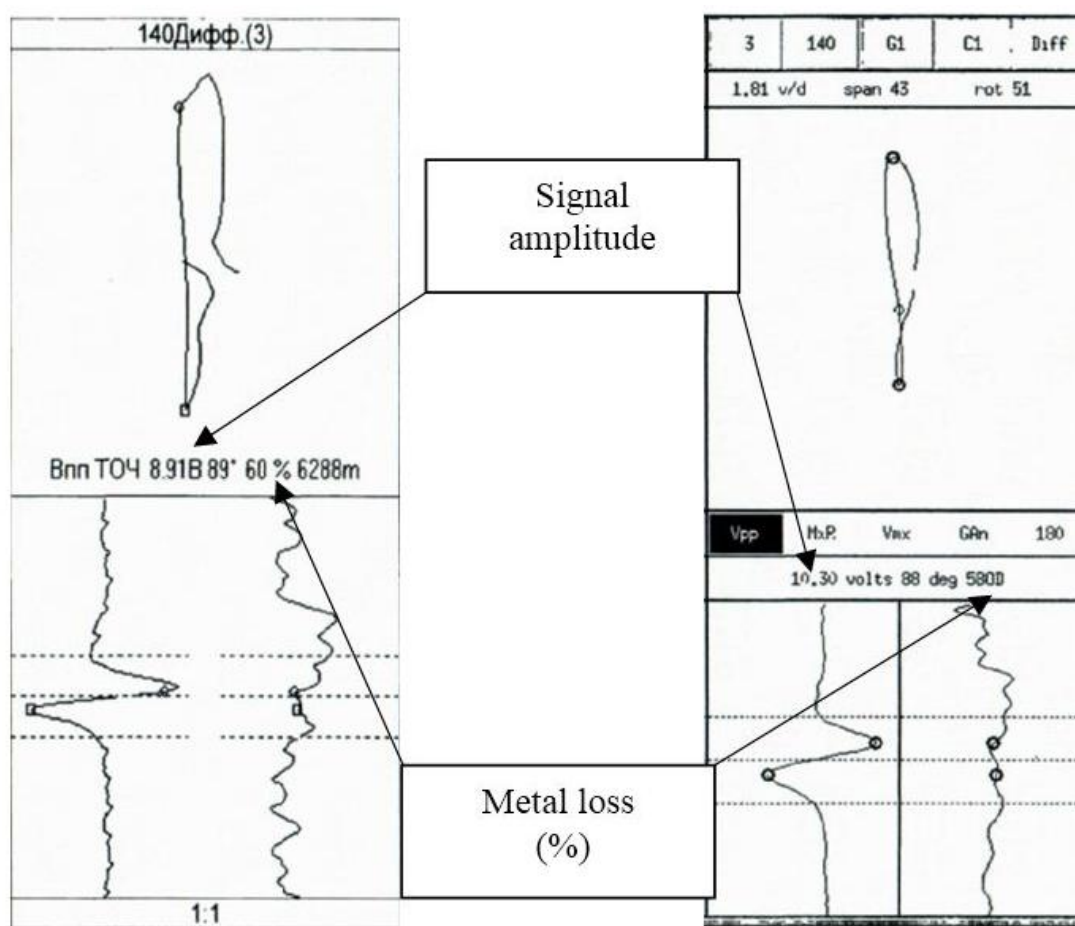
Fig. 3. Critical round shape corrosion pitting:
a – Defect appearance on the HET surface;
b – Defect appearance on the metallographic section (metal damage depth up to 1.25 mm (83 %);
c – ECT results by "TEDDY-8" system;
d – ECT results by "MIZ-30" system.

The comparative analysis for the measuring data of the metal loss obtained by ECT “TEDDY-8” and “MIZ-30” systems shows good enough correspondence for all the analyzed defects (Fig. 3 *c, d*; Fig. 4 *c, d*; Fig. 5 *c, d*). A percentage of the damaged metal according to the metallography exceeds the ECT data in all the analyzed cases. Predominantly the difference is equal to 10–15 %, in separate cases up to 25 % (Fig. 3). The probable cause of ECT understating data for a defect depth may be in metal loss data averaging along a length of more than 1 mm. It is necessary to take this fact into account while deciding about the tube blank off after testing.

The measured signal amplitudes obtained by ECT “TEDDY-8” and “MIZ-30” systems vary within 20–30 % range (Fig. 3 *c, d*; Fig. 4 *c, d*; Fig. 5 *c, d*). Such a difference in readings may be attributed to calibration differences, distinctions in used probe specifications, constructive peculiarities and system software.

When making a decision on SG HET blank off based on ECT results, it is necessary to estimate the possible opening of the detected defect, namely the possibility of leak and its size provided that operation continues. Therefore, based on metallography, the most dangerous are the defects of a corrosion pitting type, though this conclusion can be made not only after the scrutinizing the metallographic section. As a rule, the pitting is filled with corrosion products, *i.e.* oxides. The investigations showed that oxidation is accompanied by expansion with any possible reagents. This leads to bursting stress inside the pitting and consequently to tensile stress around. As a result, we have metal cracking around the pitting, mainly longitudinal ones. The mechanism and growth kinetics of corrosion pitting are not fully investigated for now. The regularities of their growth stopping are not clear. But even if oxidation stops stress is still observed in the pitting in the surrounding metal due to metal heterogeneity which appears particularly owing to distinction in thermal expansion coefficient. Thus, the tendencies towards crack propagation are still displayed and the possibility of tube leak is preserved respectively. The leak value immediately after its identification is proportional to pitting area and may appear to be critical.

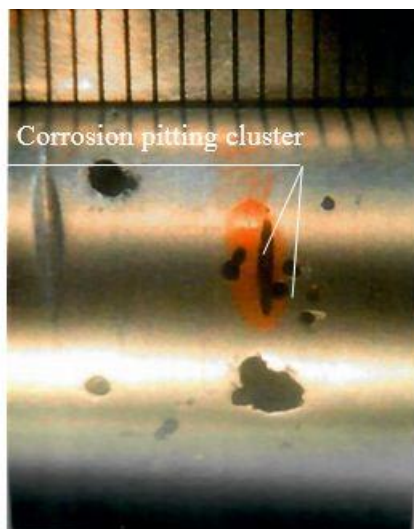
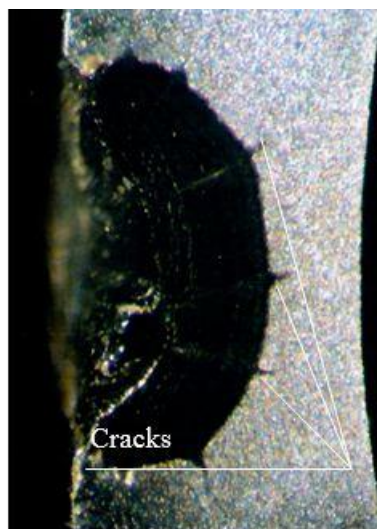
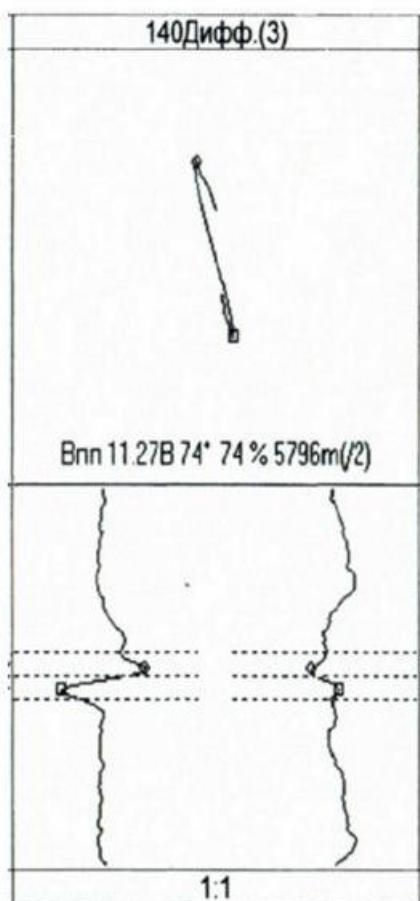
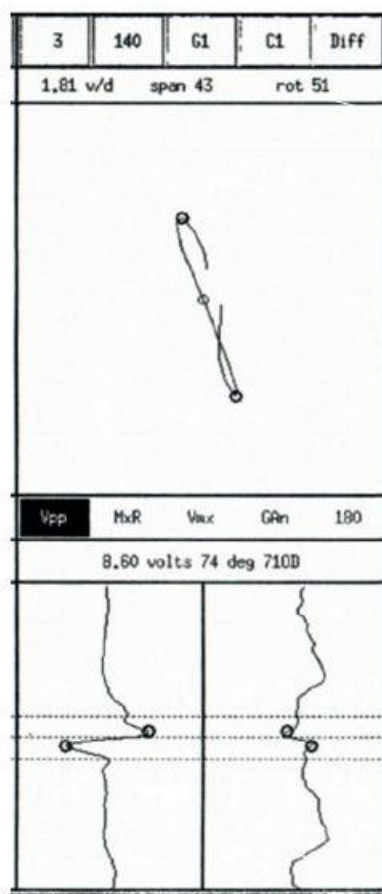
Fig. 4. Critical irregular shape corrosion pitting:
 a – Defect appearance on the HET surface;
 b – Defect appearance on the metallographic section (metal damage depth up to 1.2 mm (80 %);
 c – ECT results by “TEDDY-8” system;
 d – ECT results by “MIZ-30” system.

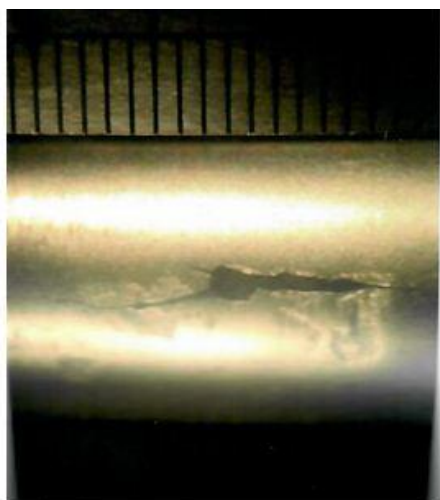
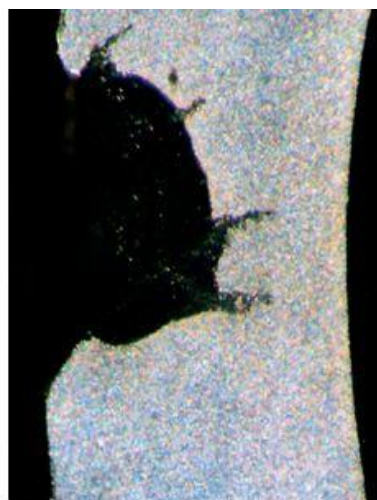
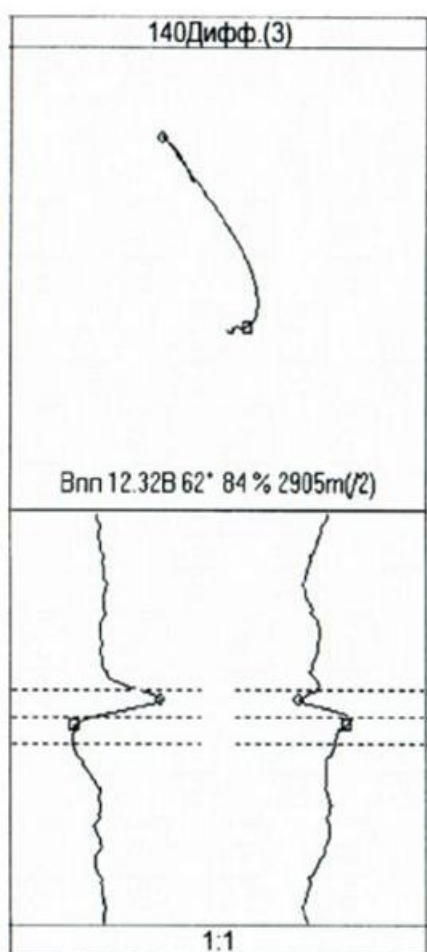
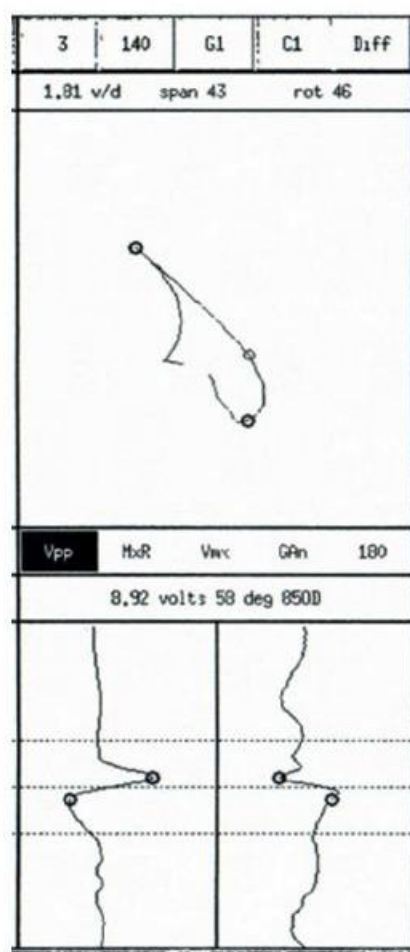
Based on the results of the performed analyses, it was determined that corrosion pitting is the most frequent one to occur. The pitting corrosion is known as the most dangerous type of local corrosion. Corrosion pitting defects were conditionally distributed into critical and subcritical during the test performance. Critical defects are those which make a further HET operation dangerous. The tubes having such defects should be blanked off. From the standpoint of ECT, the critical corrosion pitting is characterized by a great percentage of metal loss (from 60 to 100 %) at signal amplitude equal to 10–20 V (Fig. 3, 4 and 5). Characteristic properties of these defects from the metallography standpoint are as follows. In all the analyzed cases these are large corrosion pitting which have round, oval or elongated longwise shape of the tubes. The defects have the dimensions in 2–4 mm range on the tube metal surface. The corrosion products sediments have the intricate shape in the form of coaxial circles positioned around a central hollow – a pitting core. In most cases the cracks are propagated from corrosion pitting predominately longways the tube surface; the cracks may be up to 20 mm long (see Fig. 5, a).

Fig. 5. Critical wedge-shaped corrosion pitting (the total length up to 20 mm):
 a – Defect appearance on the HET surface;
 b – Defect appearance on the metallographic section (metal damage depth up to 1.32 mm (88 %);
 c – ECT results by “TEDDY-8” system;
 d – ECT results by “MIZ-30” system.
