Lidia Bohun¹, Eduard Pleshakov², Sergiy Shvachko³

FAILURE ANALYSIS OF A MOTOR VEHICLE SUSPENSION HELICAL SPRING

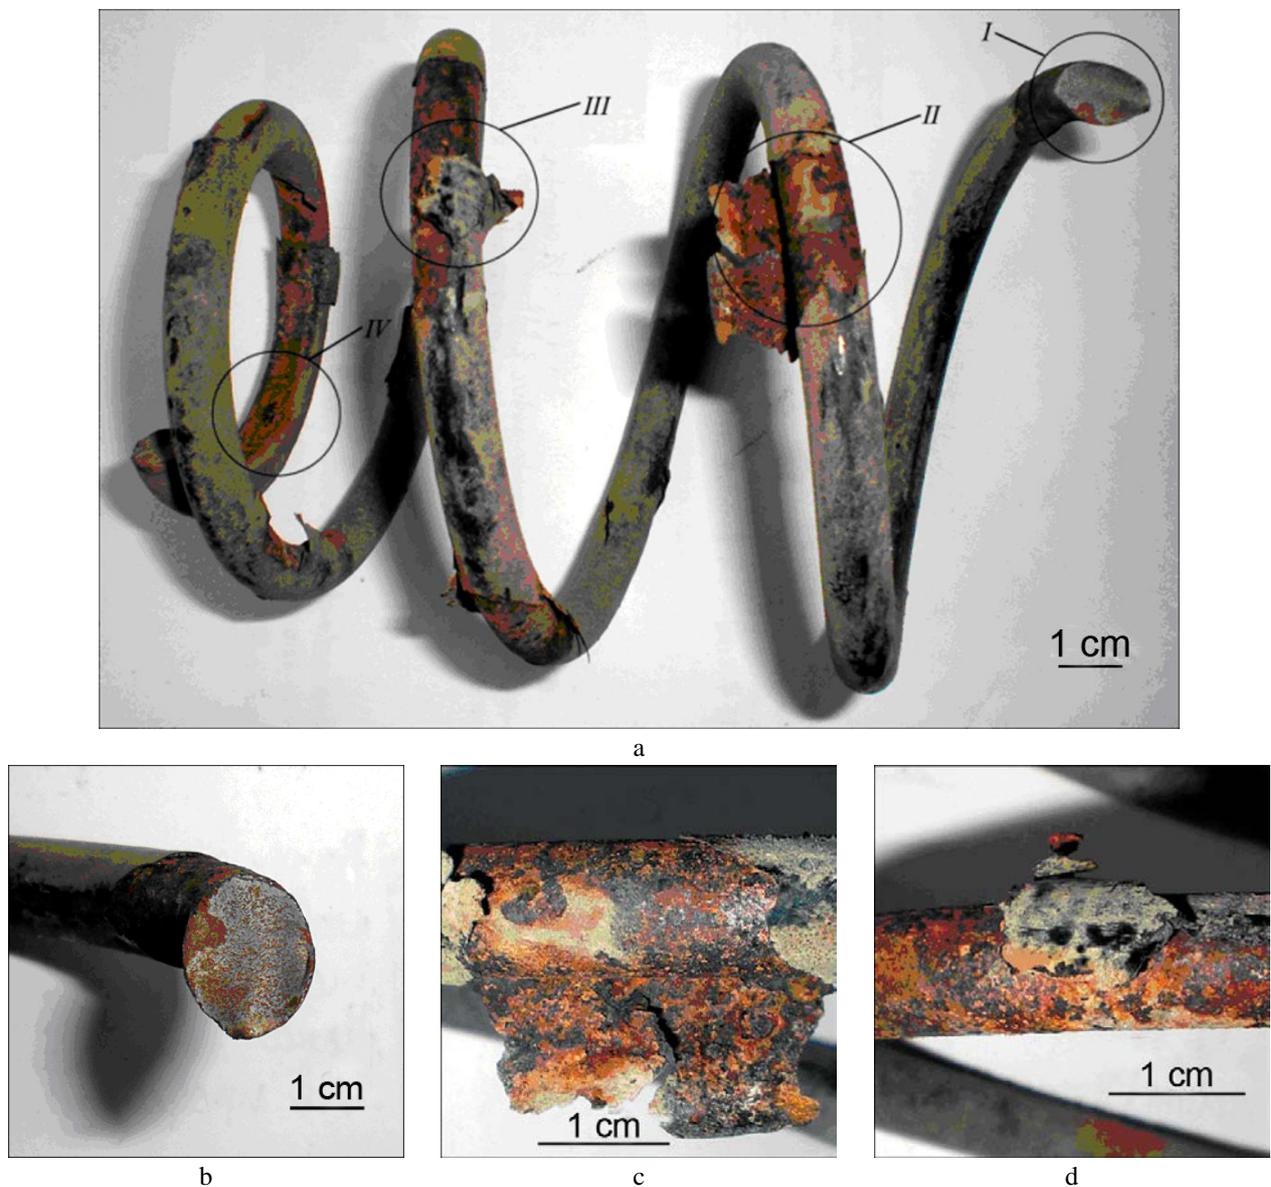
The fractured spring has the form of a barrel-shaped helix coiled to the right (Fig. 1, a). The outside maximum diameter of the spring is 108 mm, the minimum diameter is 76 mm, the total height of the unloaded spring is 336 mm. The total number of spring coils is 7 and the spring wire diameter is 10 mm. The spring weight is 1.25 kg. The fracture of the spring occurred on the middle coil having the largest diameter.

Fig. 1. The appearance of the spring of the rear suspension of the Ford Fiesta car: a – general view; b – fragment I; c – fragment II; d – fragment III

The quality of the spring was checked visually with a magnifying glass with 5 times magnification in accordance with DSTU 8429:2015 [15]. The appearance of the spring and the fracture was documented using a Casio Exilim 8.1 Mega Pixels camera (Fig. 1, *a, b*). During the inspection, no cracks, hairlines, rolled-in scales, electric burns, small dents, scratches, marks of spring coiling tool, and the remains of lubricants were observed on the surface of the spring. Instead, traces of rust and erosion of the protective coating were observed, which led to its exfoliation from the spring surface (Fig. 1, *c, d*).

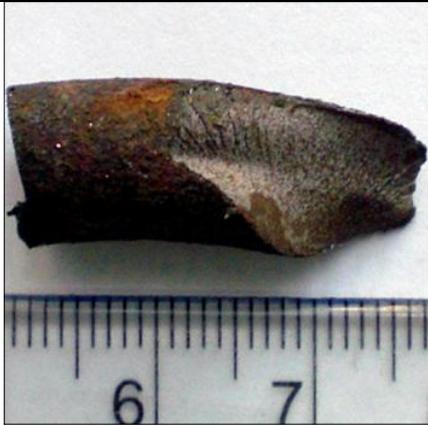
1	– macrofractographic (MBS-9 microscope); OM; $\times 1 \dots \times 7$
2

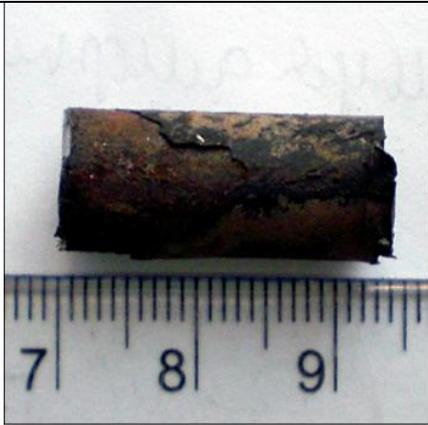
2	– microstructural in the state after operation: <ul style="list-style-type: none"> • general microstructure; • non-metallic inclusions; • the depth of the decarburized layer; • defects; – determination of the chemical composition of the steel: X-ray fluorescence analysis (ElvaX)
3

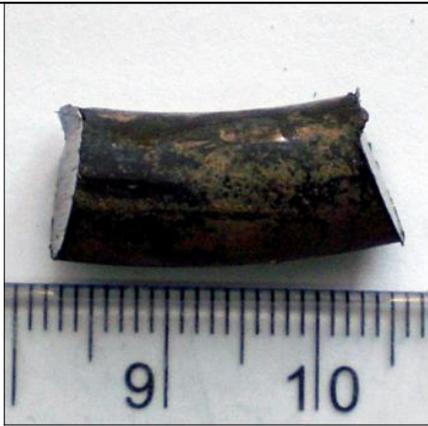
3	– microstructural after annealing to determine the carbon content in the steel

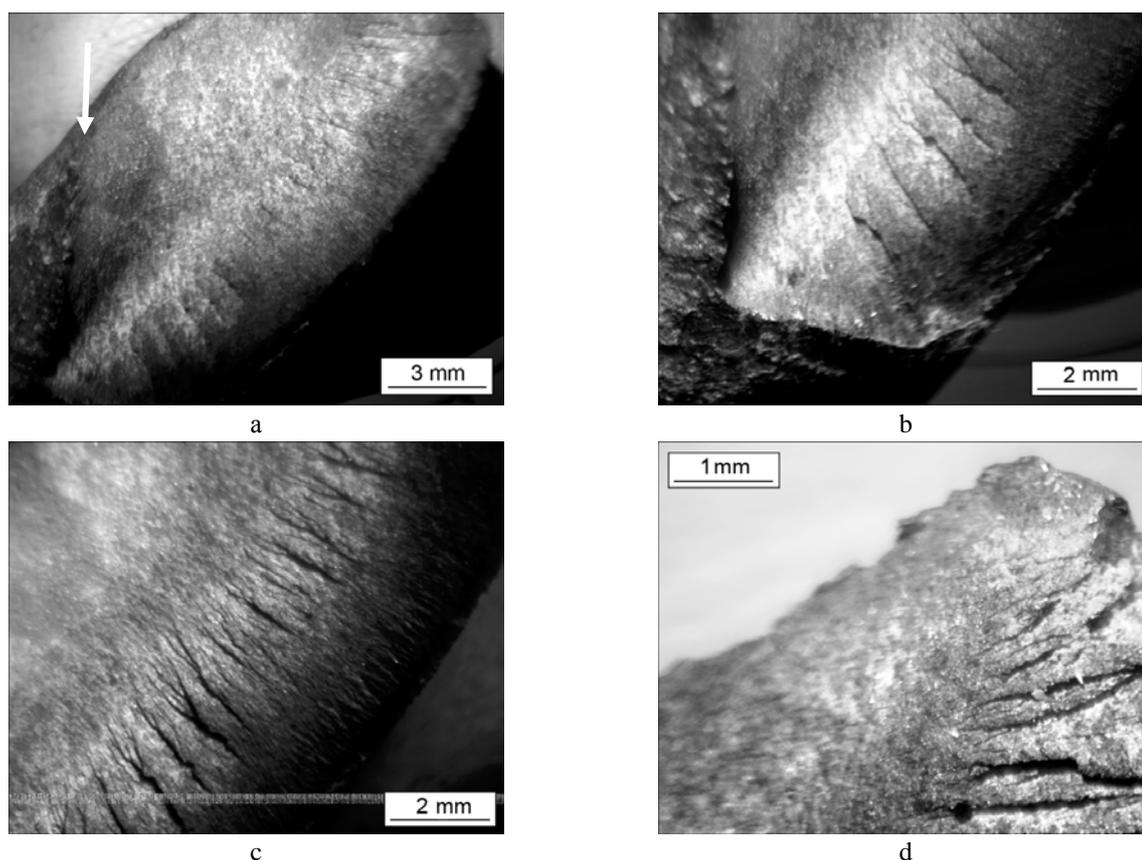
Macrofractographic studies of the fracture surface were performed using an MBS-9 microscope at magnifications of up to 7 times. The fatigue crack propagates from the fracture origin (Fig. 2, *a*, indicated by an arrow) with the reorientation of the crack plane along the spiral surface to the central axis of the coil wire (see Table 1, sample 1). The zone of the steady fatigue crack propagation is smoothed and identified by fatigue ridges – traces of movement of the crack front, which diverge concentrically from the crack initiation point (Fig. 2, *a*, *b*). After depletion of the safety margin, the spring broke down quickly. The fast fracture zone with a transverse size of about 6 mm contains steps of the river pattern formed due to the spiral reorientation of the fracture surface (Fig. 2, *c*, *d*).

Fig. 2. Macrostructures of the zones of the spring fracture surface:

a – the crack origin (indicated by an arrow); b – transition from the fracture origin to the fatigue crack propagation zone; c – the fatigue crack propagation zone; d – the fast fracture zone

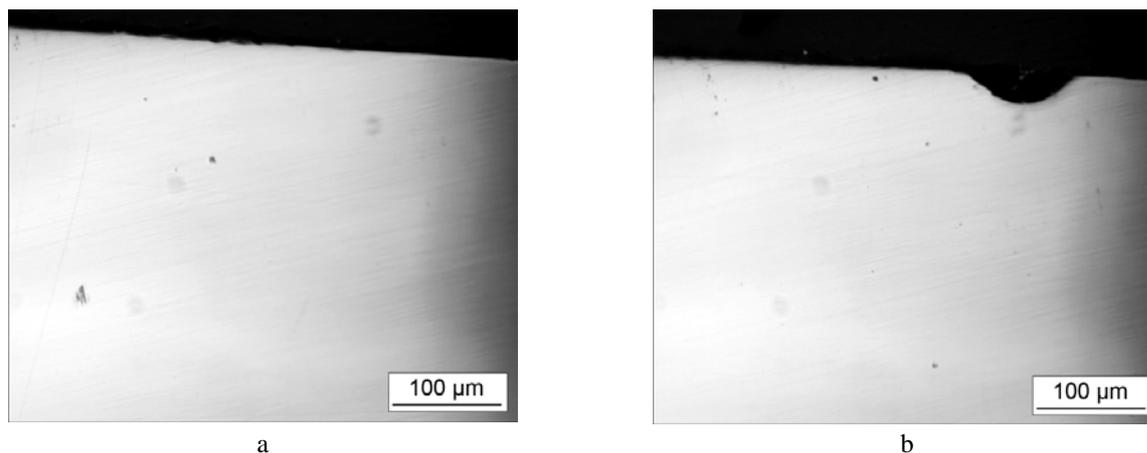
Evaluation of non-metallic inclusions in steel springs was performed according to DSTU ISO 4967:2017 (GOST 1778) [16]. A small number of dot particles of oxides (Fig. 3) and single elongated sulfides, which are usually double sulfides of iron and manganese, were found. Oxide and sulfide inclusions in their maximum size are twice smaller than the inclusions that correspond to the grade 1 of the reference scales, so they are evaluated by the grade 0.

Fig. 3. Microstructures of non-etched microsections (see Table 1, sample 1)

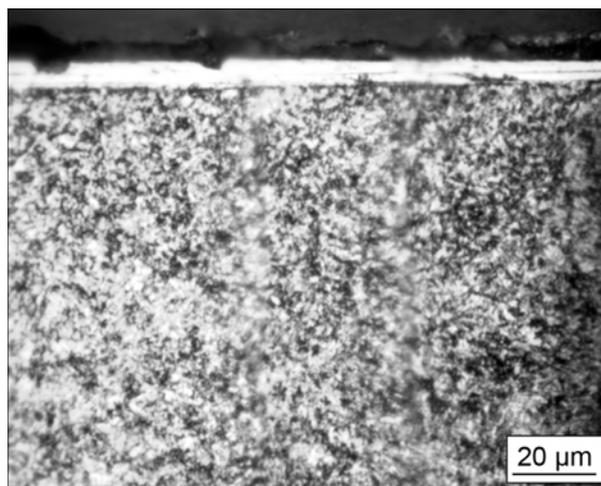
Microstructural study of the spring after operation, having a structure of troostite of tempering, found no traces of decarburization, even at the recommended allowable magnification of 500 times (Fig. 4).

Fig. 4. Microstructure of the spring of the Ford Fiesta car after heat treatment and application of a protective surface coating (after operation)

Microstructural studies of the spring showed that a protective coating was applied to its surface (Fig. 4). The thickness of the spring coating, which was determined by the results of three measurements, ranged from 6 to 7 μm .

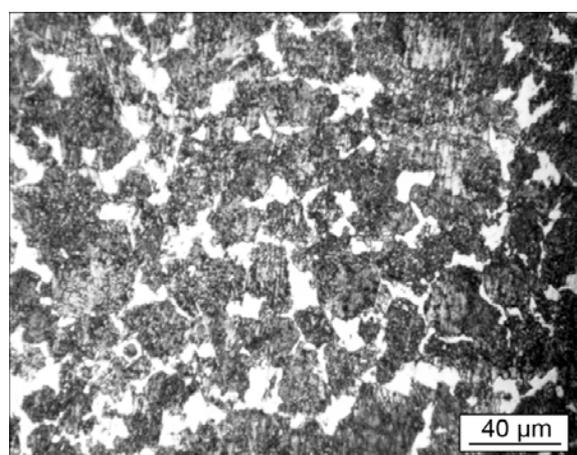
Since the device does not determine the content of light elements (up to atomic number $Z = 11$), the carbon content was determined metallographically by the structure in the annealed (equilibrium) state (Fig. 5). An approximate estimate of the carbon content in the spring steel was performed according to the standard DSTU 7175:2010 [22]. By comparing the equilibrium microstructure of the spring (Fig. 5) with scales of the standard, it is established that the microstructure corresponds to grades 3 – 4 on the scale 7. This indicates the content of pearlite in the structure of steel 70–80 %, and ferrite – 30–20 %. Thus, the approximate carbon content in the steel is 0.56 to 0.64 %.

Fig. 5. Microstructure of the spring steel after annealing

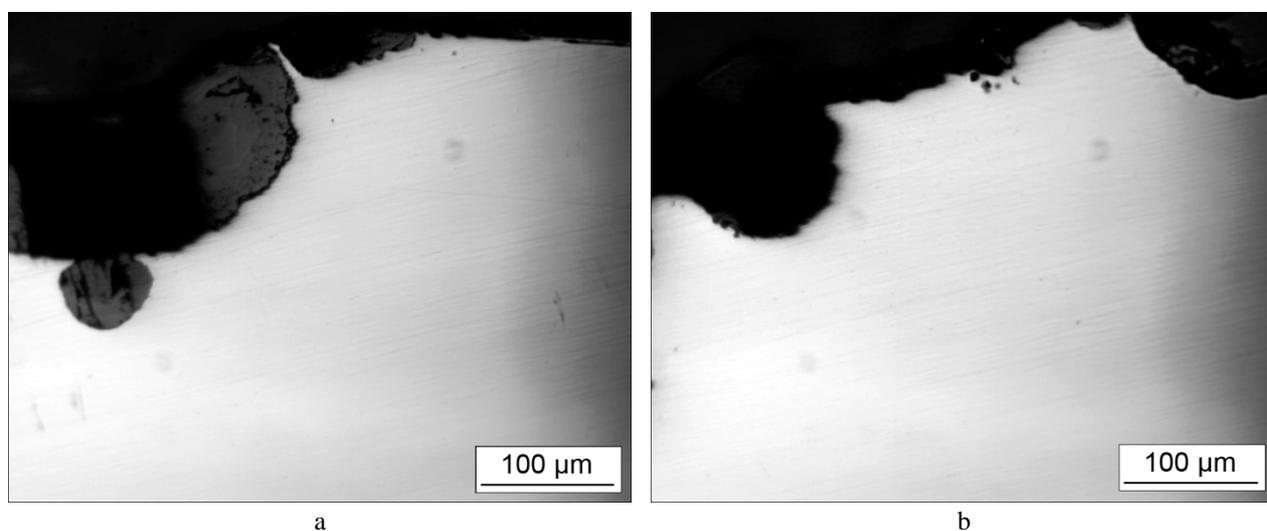
Visual assessment of the coating according to DSTU 3830-98 [27] and microstructural studies of the surface layer of the spring after operation revealed corrosion damage in places of exfoliation of the protective coating (Figs. 1 and 6). External inspection of the spring after operation showed that the coating was exfoliated on large surfaces (Fig. 1). The metallographic analysis revealed non-uniform selective corrosion, which causes exfoliation of the protective coating and spreads to the depth of the product in the form of pitting damage (Fig. 6). One of such deep pits became the initiation site of the main fatigue crack in the spring.

Fig. 6. Microstructure of corrosion damage to the spring surface in places of exfoliation of the protective coating

Instead, extensive exfoliation of the protective coating was found. Local corrosion damage in the form of deep pits, which formed in unprotected areas under the influence of operational factors, caused fatigue fracture of the middle coil of the barrel-shaped spring, which operates under conditions of more severe stress in comparison with other coils. The analysis of deformation fields performed in the work [28] confirms the fact that in progressive springs, the central coils are most deformed in contrast to linear cylindrical springs, in which the deformation of coils is the same.

Thus, the cause of the failure of the rear suspension spring of the car was the corrosion fatigue of the material due to the simultaneous action of the corrosive environment and cyclic alternate loading.

The research can be used to understand the importance of adhesive strength and wear resistance of protective coatings on the spring surface. Their local exfoliation causes subsequent corrosion damage to the spring, which stimulates its fatigue fracture.
