ASSESSMENT OF ENVIRONMENTAL CONDITIONS WITHIN THE LIMIT OF THE RIPARIAN WATER PROTECTION STRIPS USING THE WEBGIS TECHNOLOGY

Abstract. The purpose of this research is the assessing of the current conditions of water protection strips in their role as an effective buffer that prevents water bodies from deteriorating due to the soil erosion and pollution. In the base of this study, the action plan is developing to improve the conditions of the water protection strips for the lakes. The approach is focused on the idea of an empirical study (based on observations and field measurements) of the environmental quality. An integral analysis of the territory of the protection strips is proposed, as well the processes and phenomena which are taking place within them, in order to obtain a clear picture of the state of the environment. In order to administrate, and to assure the visualization and transparency of this study the project blog on the "blogspot.com" platform was created with properly configured geographic interest patterns. Cartographic data were published on Google Maps and were integrated in blog. Thus, by accessing the blog, the views of the lake, the points of interest, with th

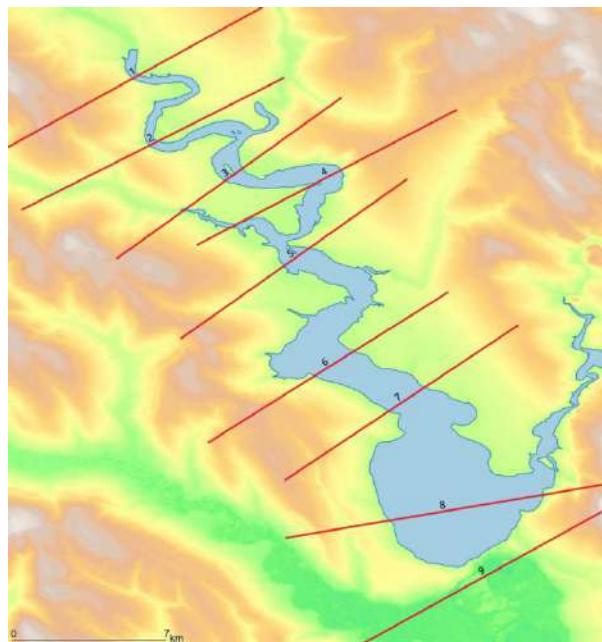
Fig. 1. Reservoir Costești-Stâncă

The reservoir Costești-Stâncă (Fig. 1) was arranged in 1978 on the Prut River, the filling of the lake took place from April 1978 until April 1979. The lake dam is 576 km from the mouth of Prut

river. The length of the lake is 60–90 km, the average width – 1 km, the average depth – 12.5 m (near the dam – 41.5 m), the volume – 735 mln. m³ – 1.1 billion. m³, with the area of the aquarium of 5–9 thousand ha, and the water catchment area – 12000 km². It ensures the seasonal regulation of Prut river run, especially in the mitigation of the floods, the river waters being used for the production of electric energy, for irrigation of land, for industry and for fish farming.

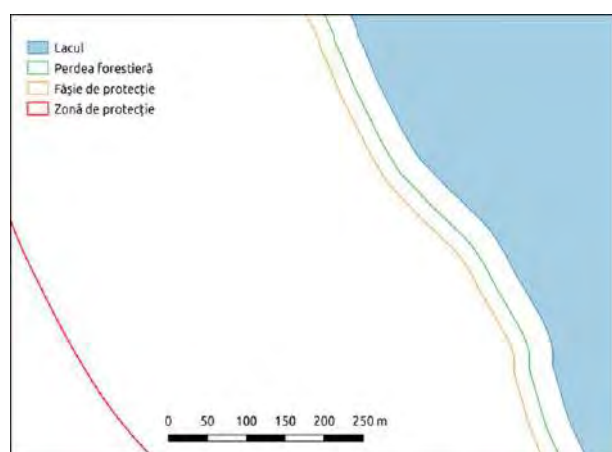
The subject of this study is represented by riparian strips of water protection of rivers and water basins as defined by Law no. 440 of 27.04.1995 (Fig. 2).

Fig. 2. Scheme for the delimitation of protection zones, windbreaks

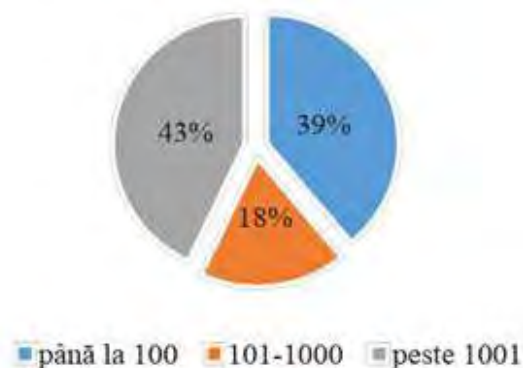
Fig. 5. Distribution of forest land according to the protection zone

In order to evaluate the environmental conditions of the water protection strips along the Costesti-Left reservoir, the study is being focused on the analysis of the forest lands on a distance of 100 m, 101–1000 m, and over 1000 m from the surface of the water (Fig. 5).

In the case of the Costești-Stâncă reservoir, 39 % of the forest lands are located 100 m from the water, 18 % – 101–1000 m and 43 % over 1000 m.

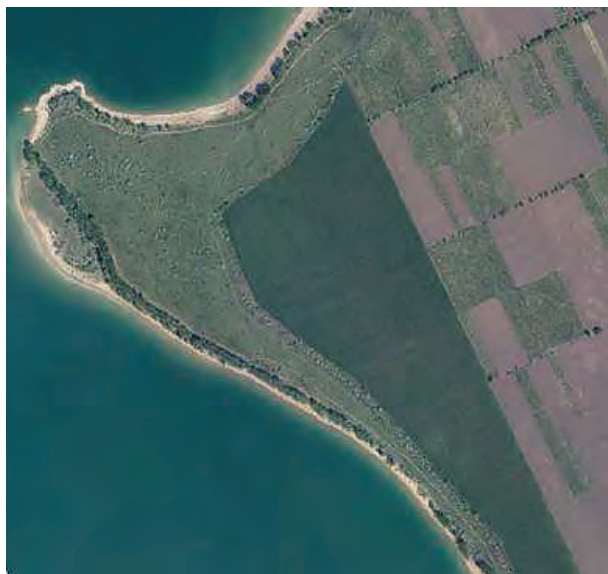
As a result of the site review of existing riparian protection strip, the length of about 11.5 km is located on the territory of Duruitoarea Nouă and Dumeni commune. The strip was created with the creation of the Costești-Stâncă reservoir and is currently discontinuous in its length (Fig. 6). The species that constitute the protection strip are the Euro-American poplar, the willow and the sail. The willow have regenerated naturally over time. Natural grassland regenerations are also found in the meadows in the immediate vicinity of the coastal protection strip.

Fig. 6. Protected coastline
in the Duruitoarea Noua village

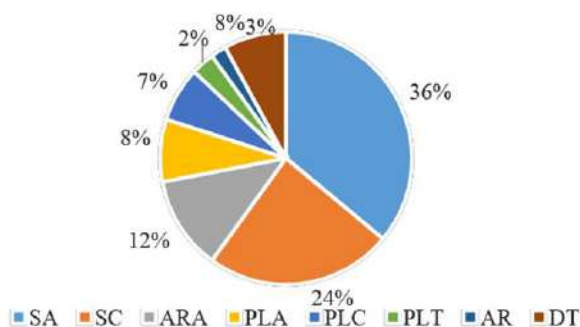
The water catchment area and the forests near the Costești-Stâncă reservoir are composed of the following species: willow (SA – 36 %), acacia (SC – 24%), American maple (ARA – 12 % white poplar (PLA – 8 %), gray poplar (PLC – 7 %), tremulous poplar (PLT – 3%), tartar maple (AR – 2 %) and various hardwoods – 8 %). The distribution of the occupied area of the species is shown in Fig. 7. Of the above, it is noted that predominantly the following species predominate in the composition of the arboretums: the willow, the acacia and the American maple. The other species are in a smaller proportion.

Fig. 7. Composition of river protection strips

The state of species vegetation on some sectors is currently satisfactory with a normal vitality. The consistency of the protection strip ranges from 0.3 to 1.0. On sectors with low consistency (up to 0.6) there is a need to intervene with works to regenerate it.

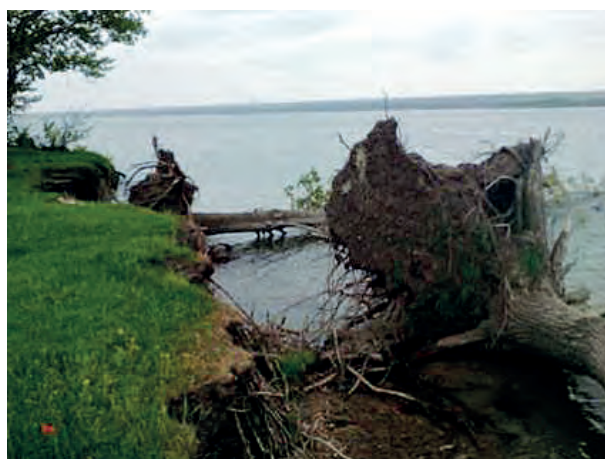
The age of Euro-American poplar is advanced in comparison with the age of technical exploitation. Thus, interventions are needed to regenerate coastal protection strips. The acceleration of the regeneration works of the riparian protection strip is also due to the shores of the banks due to the erosion caused by the waves and the weight of the trees (Fig. 8).

Fig. 8. Degradation of shores due
to wave erosion and tree weight

Describing the coastal protection strip as it is currently being constructed, there is a lack of consolidation band. Here it is necessary to intervene with bank consolidation works and, if necessary, to create the consolidation band.

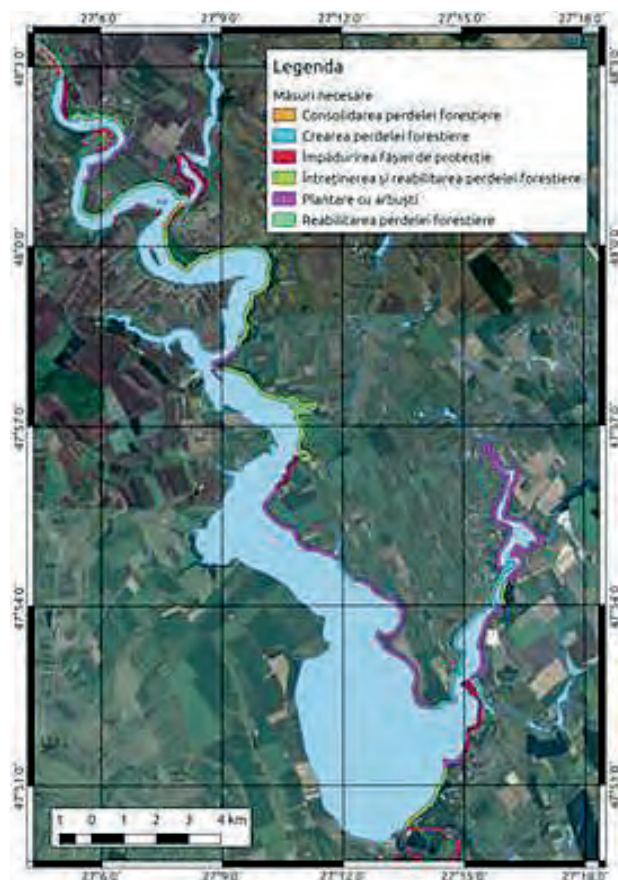
Fig. 9. Localization of measures to improve the state of protection strips of Lake

Using the GIS mapping [References of Law number,..., 2016; Geoportal NSDI of Moldova, http://www.indes.gov.md/geoportal_inds] the localization of the actions on rehabilitation creation of protection strips was made (Fig. 9, Fig. 10) and location of solid waste landfills requiring action (Fig. 11).

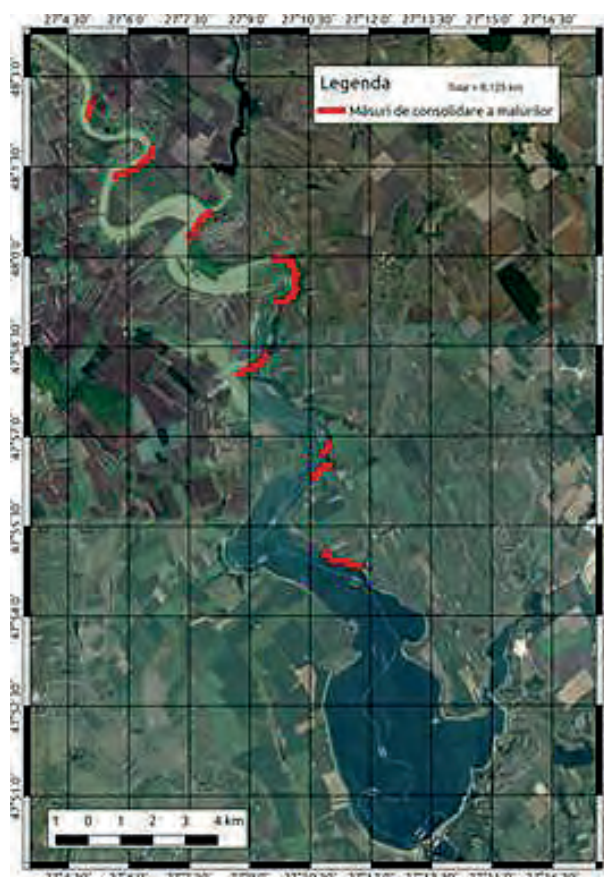
Fig. 10. Localization of measures to strengthen the shores of reservoir

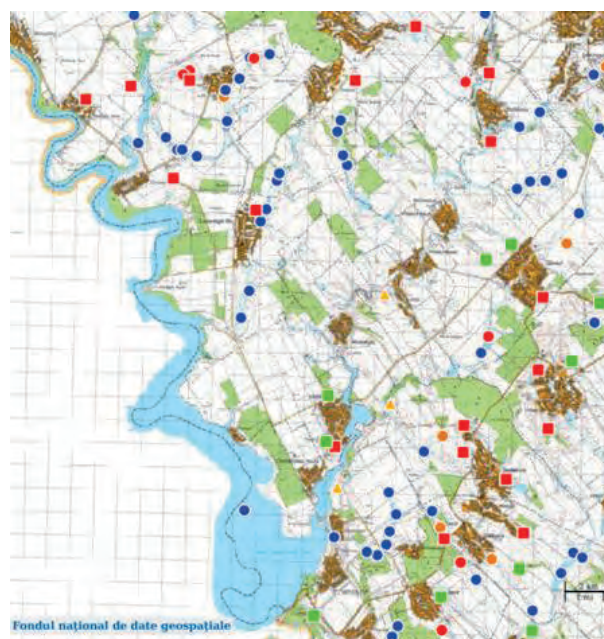
Fig. 11. Localization of solid landfills in the vicinity of Costesti-Stânca Lake (green squares – authorized warehouses, red squares – unauthorized landfills)

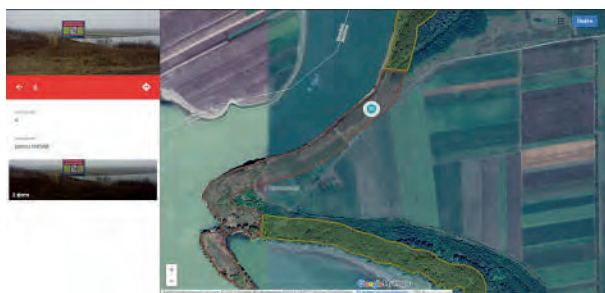
Figure 12 shows the location and picture (photos) of the information panel on the protection zone of Lake Costesti-Stinca.

Fig. 12. Viewing the information panel for the protection zone of Lake Costesti-Stinca
