Vol. 7, No. 2, 2021

MONKS' CEMETERIES OF THE HOLY DORMITION UNIV LAVRA. THEIR CURRENT CONDITION AND RESTORATION ISSUES

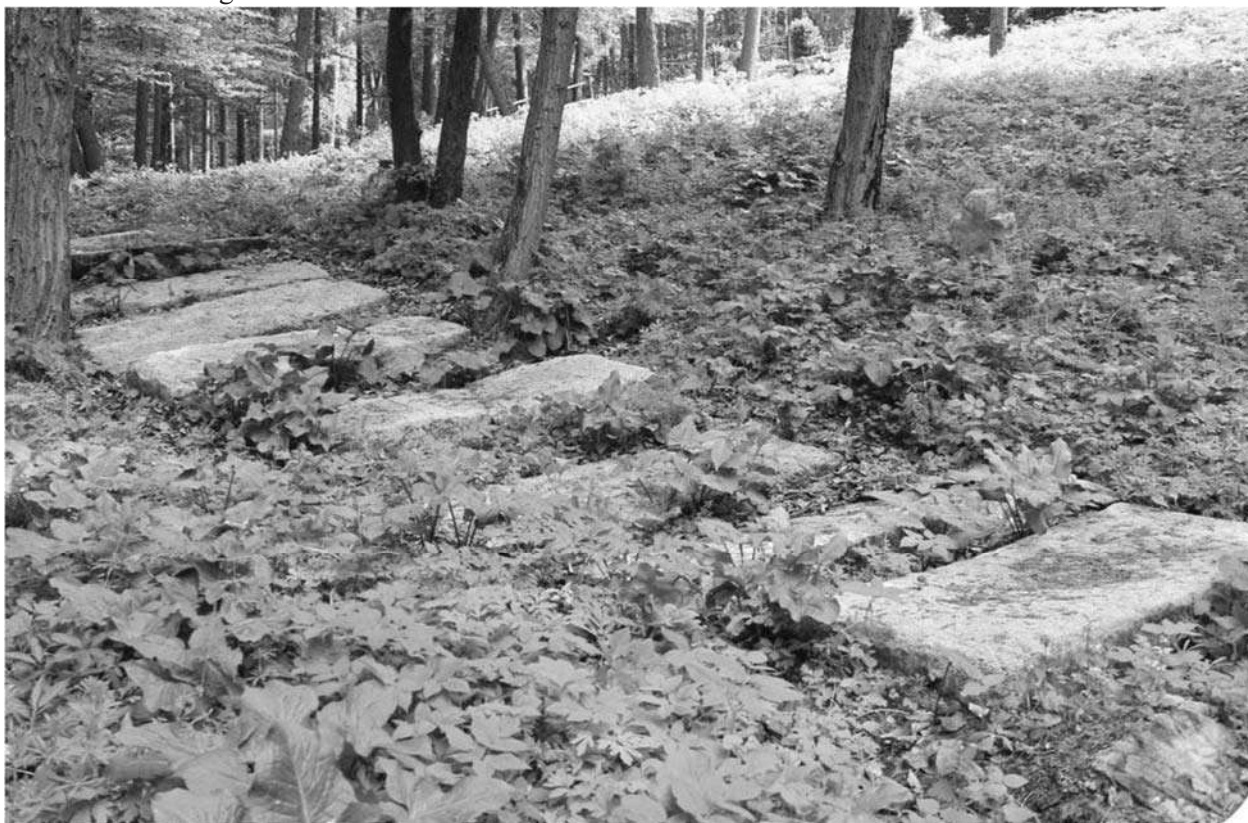
This is an example of a cemetery with sub-slab burials (Fig. 1), which is not common in our lands. The first reports of sub-slab burials in Galicia are known from the middle of the mid-nineteenth century. We find these reports in the works of archaeologists. Participants of the expeditions, who investigated the mounds on the Halych-Volyn border, in addition to the descriptions of the excavated mounds, noted the presence of large displaced slabs in the area. There were no inscriptions on their surfaces. Gradually, such sub-slab burials were discovered and studied more, and archaeologists are inclined to believe that there is a widespread practice in Galicia of sub-slab burials within various necropolises of the medieval city (Lutsyk, 2019). The cemetery is not fenced and it is difficult to understand where it begins and where it ends. This cemetery is dissolved in the surrounding landscape. Judging by the number of tombstones we can see in the cemetery today, it is very likely that some of the crosses and slabs are hidden underground. To finally determine the parameters of the cemetery, the number of burials and preserved tombstones, it is necessary to conduct detailed archaeological research.

Fig. 1. The old monks' cemetery with sub-slab burials in Univ

The surviving sub-slab burials are arranged in rows from north to south, and the burials themselves are oriented east-west. This can be judged from the inscriptions and images that are stored on separate plates. All plates are approximately the same size. That is, the difference in width and length between the plates varies within 10 cm. Of the 28 slabs in the cemetery, 18 slabs are empty. That is, without inscriptions or drawings. Some of these plates are not quite the right rectangular shape. In some, the surface of the stone is very destroyed – damaged by biology, weathered. And here it is difficult to say whether these images never existed, or whether they simply have not survived to our time. It is also worth mentioning

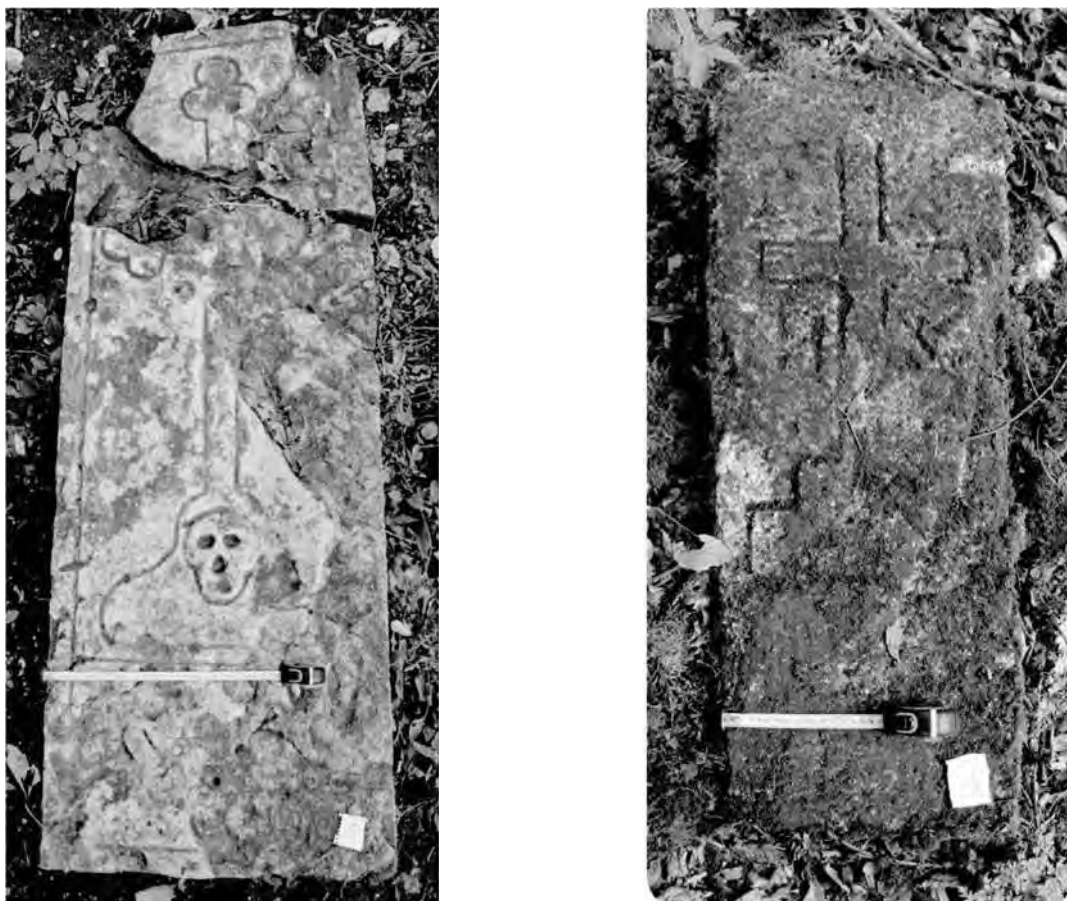
The two slabs in the cemetery are decorated with images (Fig. 2). These are linearly executed images by erasing a line. On one of the slabs is a large cross with three-leafed ends of the arms. The cross stands on a pyramid similar to the image of the mountain of the so-called “Golgotha”. The image of the mountain is with rounded corners. The image of Adam's skull is placed on the mountain. Probably below, there was still an inscription, but it is very poorly preserved. You can guess about it rather than read it. The second plate also depicts a cross. It is a Latin cross with simple rectangular arms. This cross also stands on a mountain in the form of a stepped pyramid. The lower part of the plate is very destroyed and it is not clear whether there were any drawings or text. At the top right and left of the cross you can see the traditional letters - the abbreviation of the name of Jesus Christ. Traditional, such as is usually painted on icons.

Fig. 2. Slabs decorated with images

All the objects in the ancient monastic cemetery are made of limestone. The stones are mostly the same colour, but with different types of granularity and sometimes with shells. The condition of the tombstones is unsatisfactory. Since the cemetery is located in the forest, the stone is under the constant influence of all natural factors. Biology is especially destructive here. Both crosses and slabs are quickly overgrown with moss, fungi, and so on. 9 of the 28 plates are divided, mainly into two parts. In several reflected and lost corners. In particular, one of the two plates decorated with carvings is broken. She also lost her upper left corner.

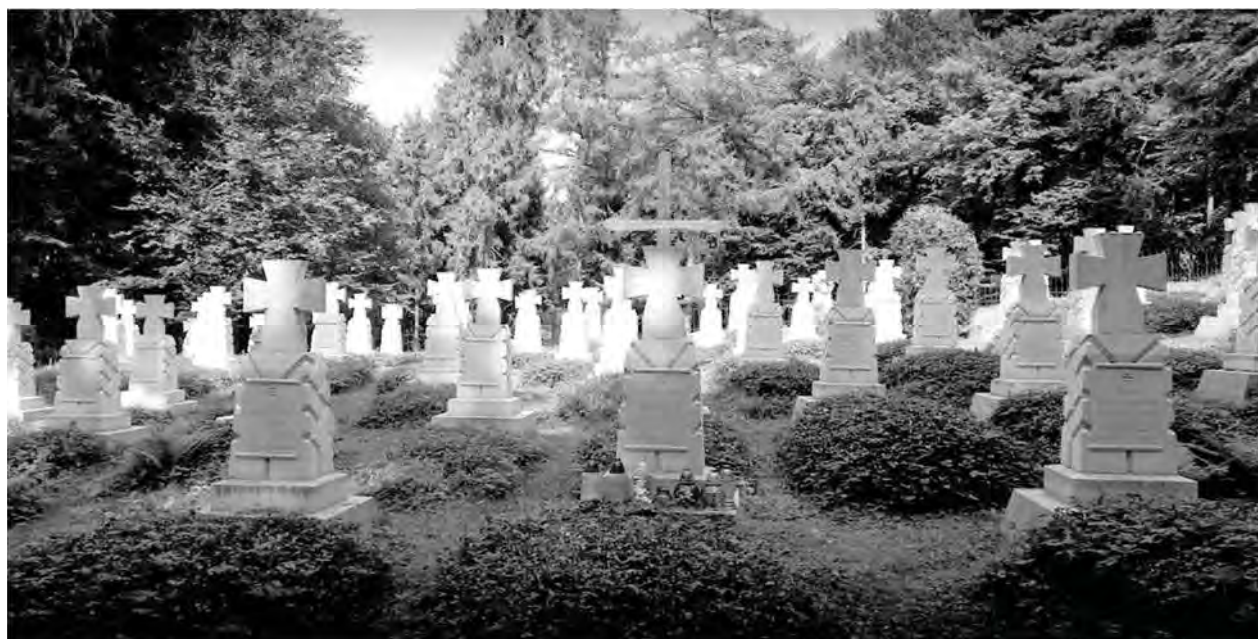
The second, newer and currently operating monks' cemetery is also located on the Chernecha Mountain in Univ (Fig. 3). Chernecha Mountain is a special holy place east of the Univ Lavra. It is on the top of this mountain that the current monastic cemetery is located, which is a place of pilgrimage for pilgrims arriving at the Univ Lavra. It should be noted that this cemetery is in good condition. The cemetery consists of identical tombstones. The graves themselves are earthenware overgrown with periwinkle.

Fig. 3. Newer and currently operating monks cemetery located on the top of Chernecha Mountain

At the head of each of the graves is a stone monument. A monument in the shape of a truncated pyramid stylized as “Golgotha”. The pyramid is crowned with a cross of the Kozak (or Maltese) type. On the pyramid, i.e. on the mountain, there is a cartouche for the inscription. The inscriptions are engraved. The monuments are arranged in straight rows from west to east. In the middle of the cemetery is a wooden cross with a round metal plate. Along the perimeter of the plate is a wreath of leaves, and in the centre of a short philosophical text about the value and meaning of life. The cemetery is fenced with a delicate metal fence. It is tidy and well-groomed. The stone tombstones are in very good condition. The stone is light with a warm shade of the so-called “ivory”. There are no traces of dirt, moisture or biology. Even though this cemetery is a place of pilgrimage and is visited by a large number of people, it is clear that the pilgrims follow cleanliness and order. The fact that the cemetery is often visited is indicated only by the presence of candles or lamps on the monuments.

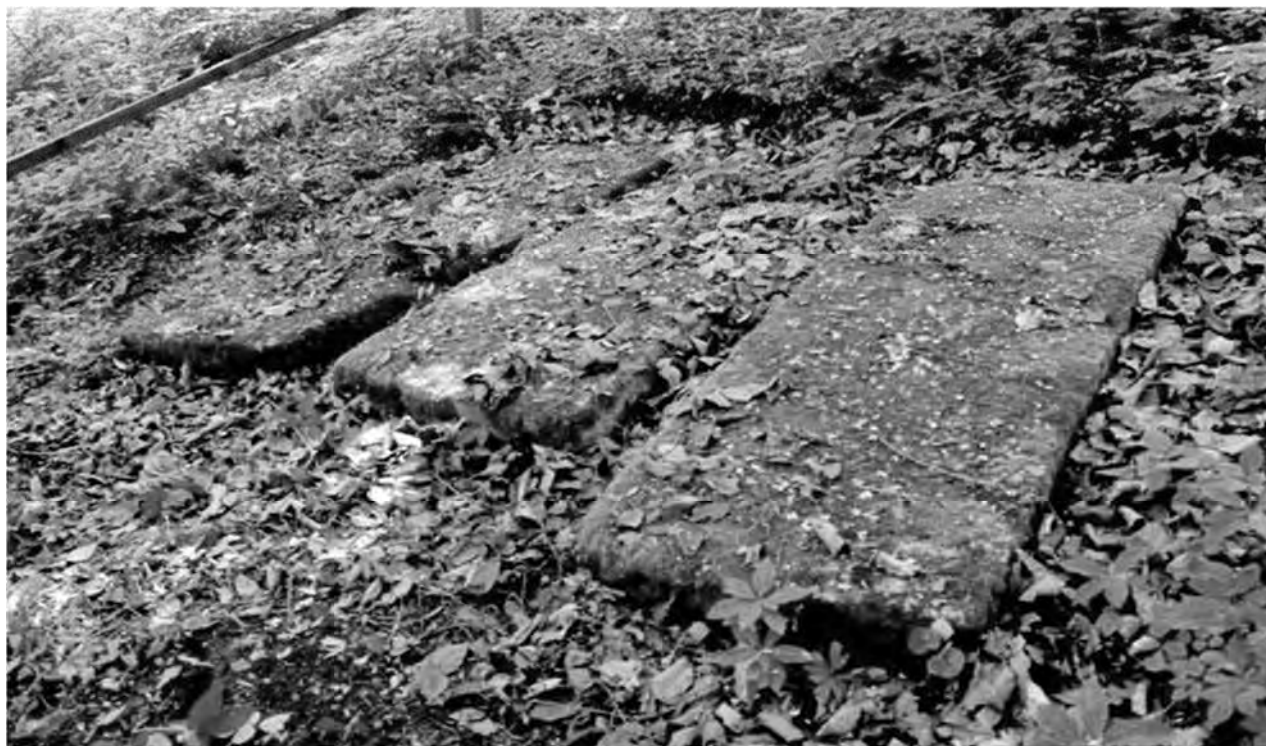
Examining the current state of the cemeteries, it became clear that the two monks' cemeteries are in a completely different state. The existing, newer cemetery on the top of the hill is well-groomed and tidy. The ancient monks' cemetery on the hillside is forgotten and abandoned (Fig. 4). This cemetery, as well as individual monuments of this cemetery, need to be restored. The territory of this cemetery is neglected. The grass is not mown, the trees grow randomly, that is, they are not pruned, do not watch how they grow, obviously many of the trees are self-seeding. There are no paved paths in the cemetery – only paths trodden in the grass. In the new cemetery on the top of the mountain, the grass is always mown, and there are no trees in this cemetery at all.

Fig. 4. The result of inaction at the old monk's cemetery in Univ

The first challenge is to tidy up the territory of the ancient cemetery. Perhaps we should take as an example the existing newer cemetery, which is perfectly arranged. The next challenge is the restoration of individual monuments. This applies again to the ancient cemetery. Restoration should be done by specialists. As for the stone crosses, they should first of all be stabilized statically – raised, levelled, strengthened accordingly, that is, do everything necessary to make the monument stand flat and strong. Next, you need to clear the crosses and slabs, respectively, if necessary, strengthen the stone material, glueing and bonding the broken parts of the tombstones. Accordingly, if necessary, the addition of lost parts. In both cemeteries there is a need for constant care, cleaning, clearing (such as snow removal in winter, fallen leaves in autumn, mowing in summer), continuous monitoring of the condition of monuments, and immediate removal or repair of minor damage. These seemingly simple steps can significantly extend the life of cemetery monuments, and hence the cemetery as a whole.
