Analysis of Eddy-Current Testing and Metallographic Examinations for Corrosion Damages of Heat Exchanging Tubes in NPP Steam Generators

Tetiana Kovalenko, Stepan Lys*, Volodymyr Vostres

Lviv Polytechnic National University, 12, S. Bandery Str., Lviv, 79013, Ukraine

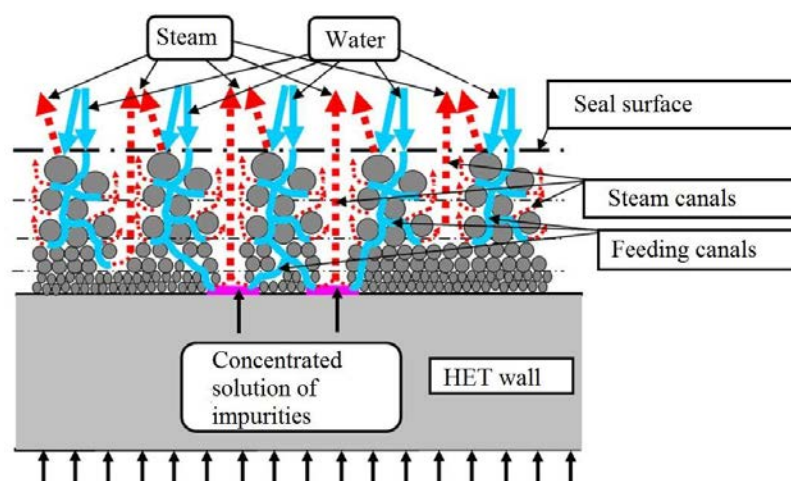
Taking into account scale porosity and its significant heat conductivity ($\approx 1.1 \text{ W/m}^2 \times \text{K}$) it is worth considering that water boiling inside scale occurs in the sheet of superheated liquid at a HET surface as well as on the surface and within scale (Fig. 2). Replacing evaporated water new portions of water come to together with dissolved impurities come to HET surface from flow core. Since the solubility of impurities in steam is lower compared to water, impurities removal by steam does not compensate for their ingress with vaporizing water. Thus, the difference in concentrations between a boundary layer and flow core appears; as the consequence diffusion materializes directed to concentration leveling. At steady-state operation of the SG, the equilibrium condition appears when convective impurity transport is compensated by their steam removal and diffusion.

Fig. 2. The diagram of water evaporation and impurity concentration under scale at the HET surface.

When SG is in rated power in the practical absence of oxygen and low water conductivity, the rate of pitting propagation is limited upon the arrival of an oxidant (copper ions for the most part) into the electrochemical reaction zone. Whereupon the electrochemical cell of pitting development is limited by scale thickness and at the initial stage with the area dimensions around the steam canal (Fig. 2) where a concentrated solution of salts is located.
